New Software for PGM Tester: SN200

**HONDA ServiceNews**

ASN 23219-40063 (0809)

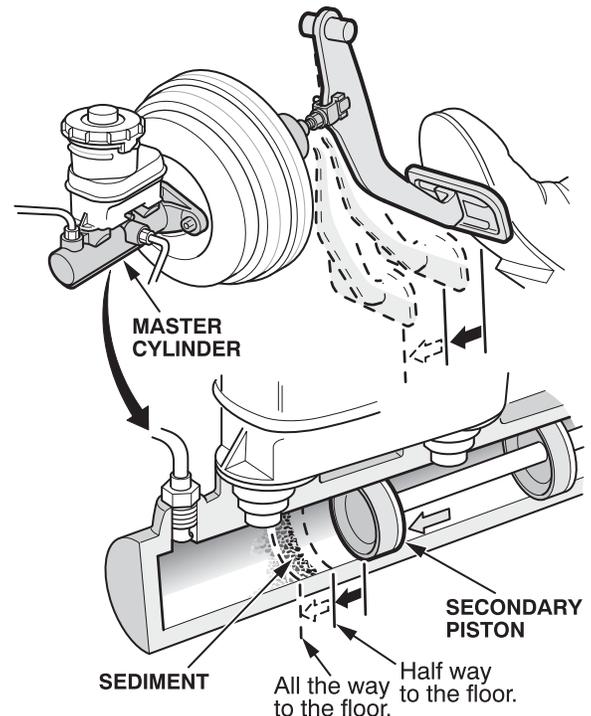
Press Brake Pedal Halfway to Avoid Piston Seal Damage

On all Honda models, if you're manually bleeding the brakes, make sure whoever's pumping the brake pedal pushes it only halfway to the floor. If the pedal is pushed all the way to the floor, you run the risk of driving the master cylinder secondary piston into any sediment or deposits that may have collected on the piston cylinder walls. If this happens, the piston seals can get permanently damaged and cause a leak.

You can also avoid this problem entirely by using any of the brake pressure bleeder equipment available through the Honda Tool and Equipment Program (call 888-424-6857).

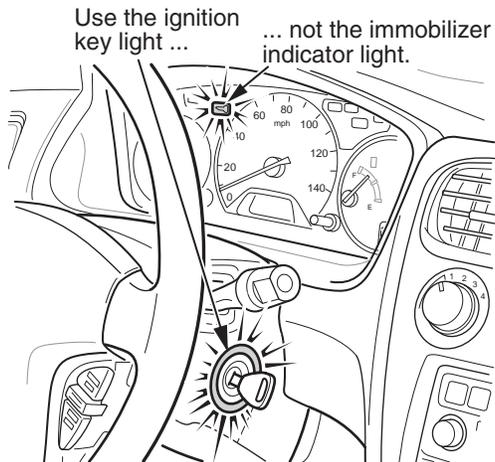
Look at Ignition Switch Light for Multiplex Mode Test

On '98–02 Accords and '99–02 Odysseys, the Multiplex Mode Test uses the reminder beeper and the ignition switch light to show the results of various tests. When running this test, make sure you're looking at the ignition key light (it's the lit-up ring around the ignition switch), *not* the green immobilizer indicator light in the gauge assembly.

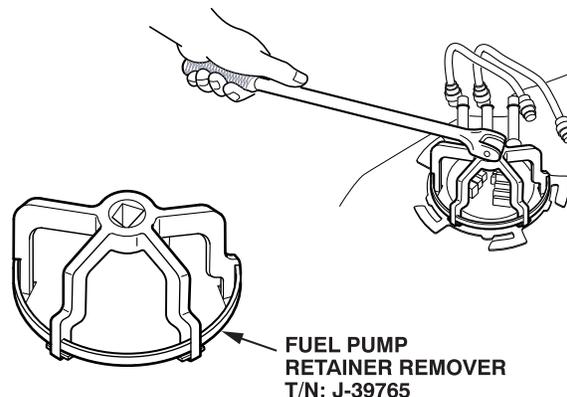
Removing the Fuel Pump Retainer: '01–02 Passport

On '01–02 Passports, to remove the fuel pump retainer on the plastic fuel tank, you need a special remover tool. If you've tried ordering the fuel pump retainer remover, J-39763, listed on pages 6C-6 and 6C-11 of the 2001 Passport S/M, you've found that the tool number is bogus and you've had to remove the retainer by whatever means you could think of. Help is on the way. In mid November '01, all Honda dealers will be shipped the proper fuel pump retainer remover, J-39765. Until then, if you need to borrow this tool, Special Tools has one of them available. Call **800-346-6327**.

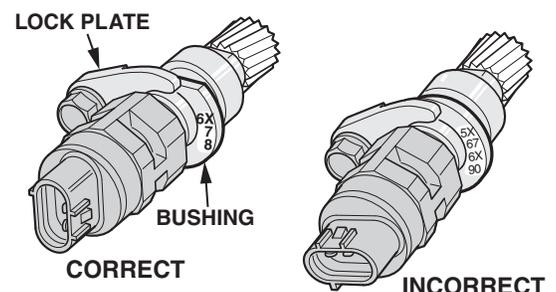
Installing the Speedo Driven Gear: '94–02 Passport

On '94–02 Passports (except 2WD models with A/T), when replacing the speedometer driven gear, make sure you install the speedometer driven gear bushing in the transfer case correctly. If you *don't*, the nylon gear life is greatly reduced. The bushing must be set in the lock plate with the **6 X 7 8** markings on the bushing clearly visible.
