Applies To: **2000-04 S2000** – ALL  
**2005 S2000** – From VIN JHMAP2...5S000001 thru JHMAP2...5S000192

**December 3, 2004**

## Intermittent Hesitation During Hard Acceleration

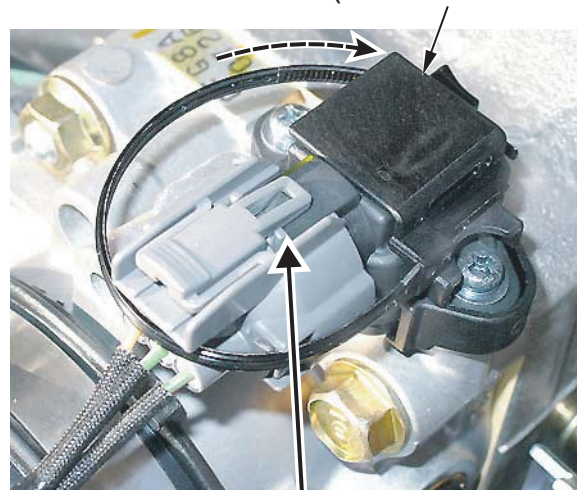
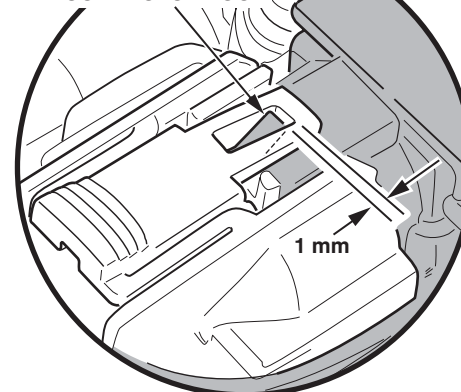
During hard acceleration, engine vibrations may cause shifting of the contacts at the MAP sensor. This may cause wear that changes the resistance of the connection at the MAP sensor.

1. Disconnect the plug from the MAP sensor, and remove the two screws.
2. Install the new MAP sensor, and reconnect the connector.
3. Route the tie wrap between the connector lock and the wires, and tighten until the connector lock shows a 1 mm gap.
