Convertible Top Is Torn at the Lock Handle and/or the Right Rear

The convertible top is torn at one or both lock handles and/or the right rear area.

There is a rough surface on the lock handle and/or the right rear frame hinge.

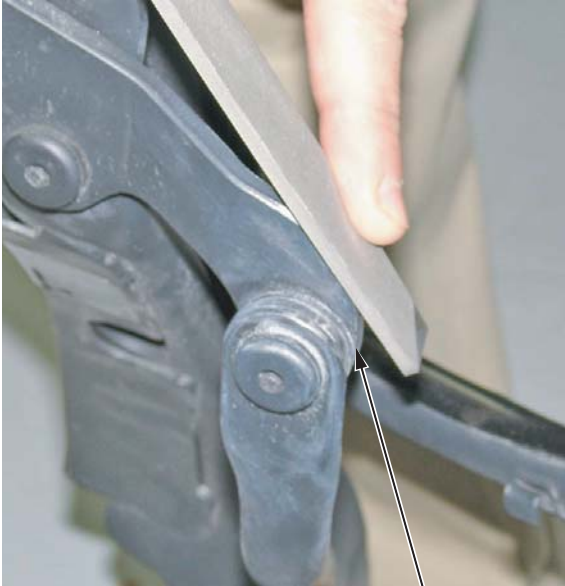
8. Locate the burrs at the right-rear of the frame hinge, then use a file to remove the burrs and any rough areas.

Remove all the burrs.

9. Remove all metal particles from the hinge and the frame.
10. Prime the filed area with a commercially available primer spray paint, and allow it to dry. Finish the primed area with a flat black spray paint.
