Center Console Lifts Up in the Back

The center console lifts up in the back.

The padding for the center floor mat pushes up the back of the center console.

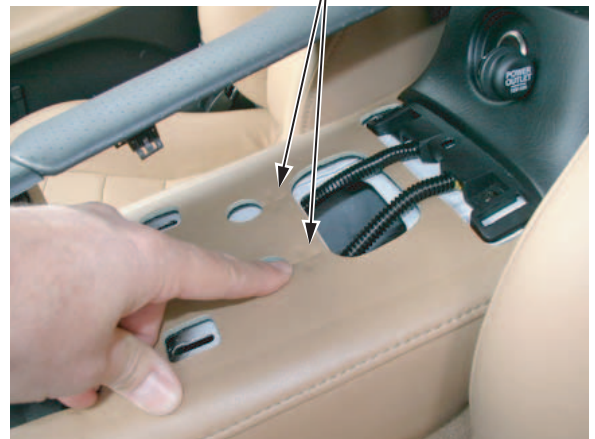
INDENTATIONS IN CENTER FLOOR MAT

1. Lift the center console from the center tunnel (eight clips). Leave the shift lever knob in place and the switch connectors plugged in.
2. Find the area on the center floor mat where the center console ribs touch.
